Lower Colorado River Multi-Species Conservation Program

Hart Mine Marsh

2019 Annual Report

March 2020

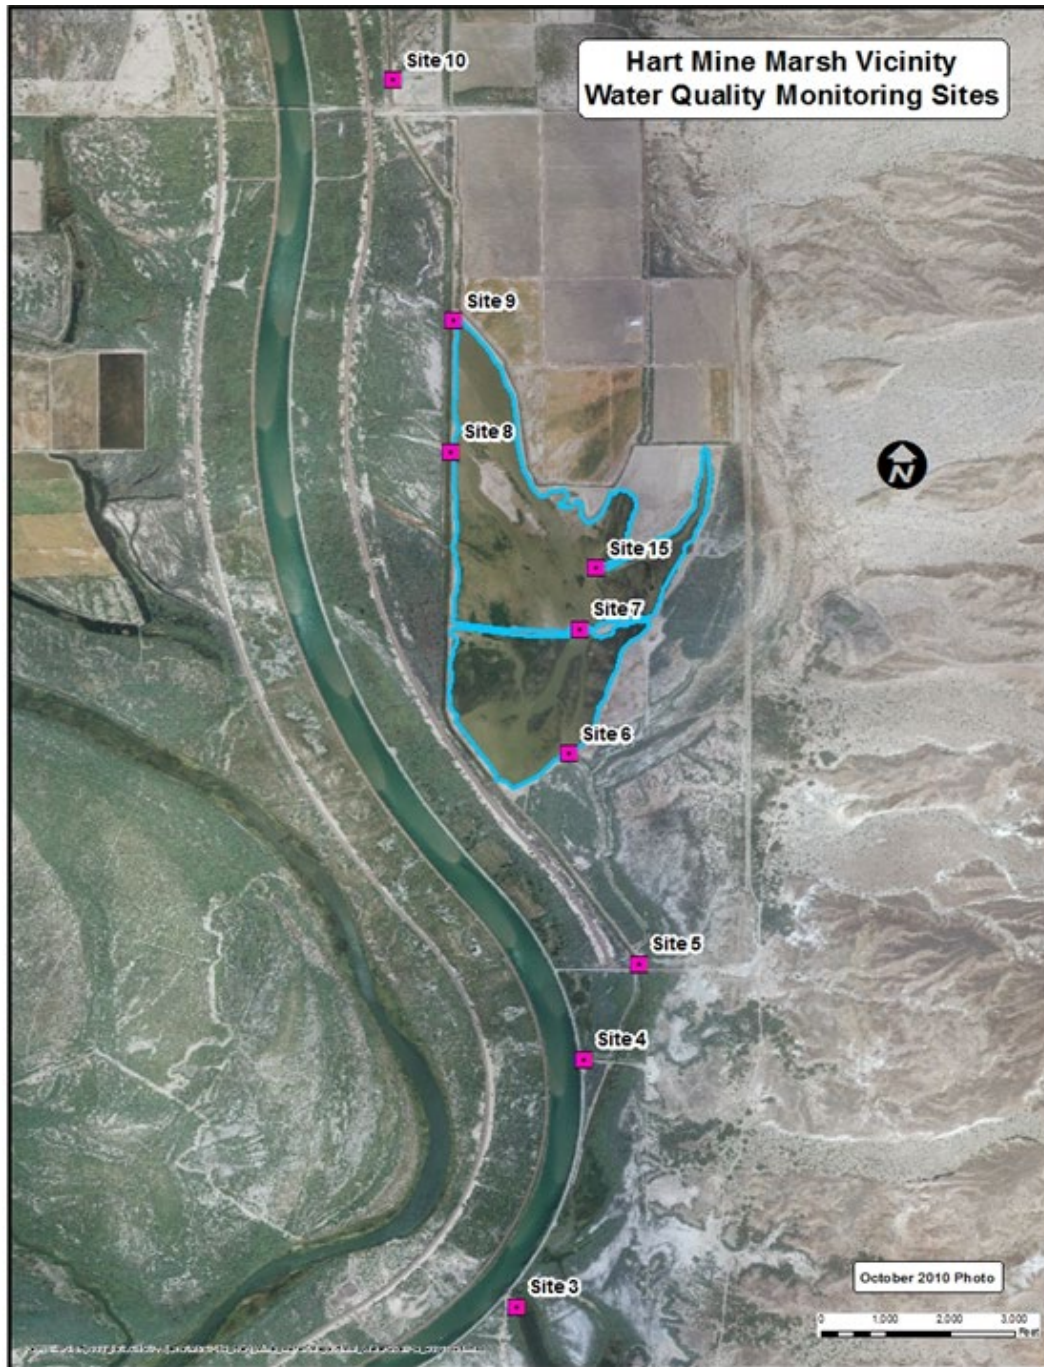
Figure 3.—HMM water quality monitoring locations.

The USFWS is responsible for monitoring and reporting on many abiotic parameters of the site as part of the interagency agreement with Reclamation. The Cibola NWR continued monthly water quality monitoring at specific points throughout the marsh. Water quality parameters, including pH, dissolved oxygen, and specific conductivity (as a measurement of total salinity), were measured throughout the fiscal year.

Figure 3 shows the locations (sites) where water quality parameters are measured and collected.
